ACTIVE VIBRATION ISOLATION SYSTEM INSTALLATION REPORT

SEM EVO 15

Model: DVIA-MB1000

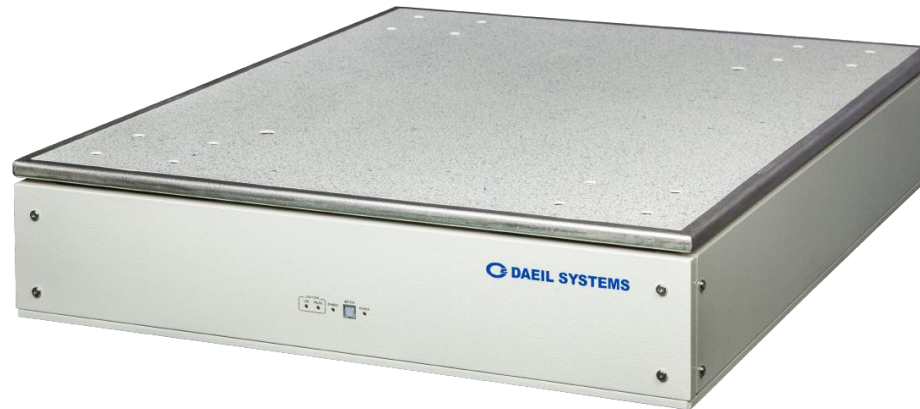
Platform Dimensions	1140 x 910 x 224 mm	
Load Capacity	500 - 1700 kg	
Actuator	Electromagnetic Actuator	
Maximum Actuator Force	Vertical: 40N, Horizontal: 20 N	
Degrees of Freedom	6 degrees	
Active Isolation Range	0.5 - 100 Hz	
Vibration Isolation at 2 Hz	≥90%	
Vibration Isolation at 10 Hz	≥99%	
Input Voltage (V)	AC100 - 240V / 50 - 60 Hz / 1A	
Power Consumption (W)	Maximum 110W, <50 W in normal operation	
Operating Range	Temperature (°C)	5 - 50 °C
	Humidity (%)	20 - 90%
Required Air Pressure	≥ 0.5 MPa (5 bar)

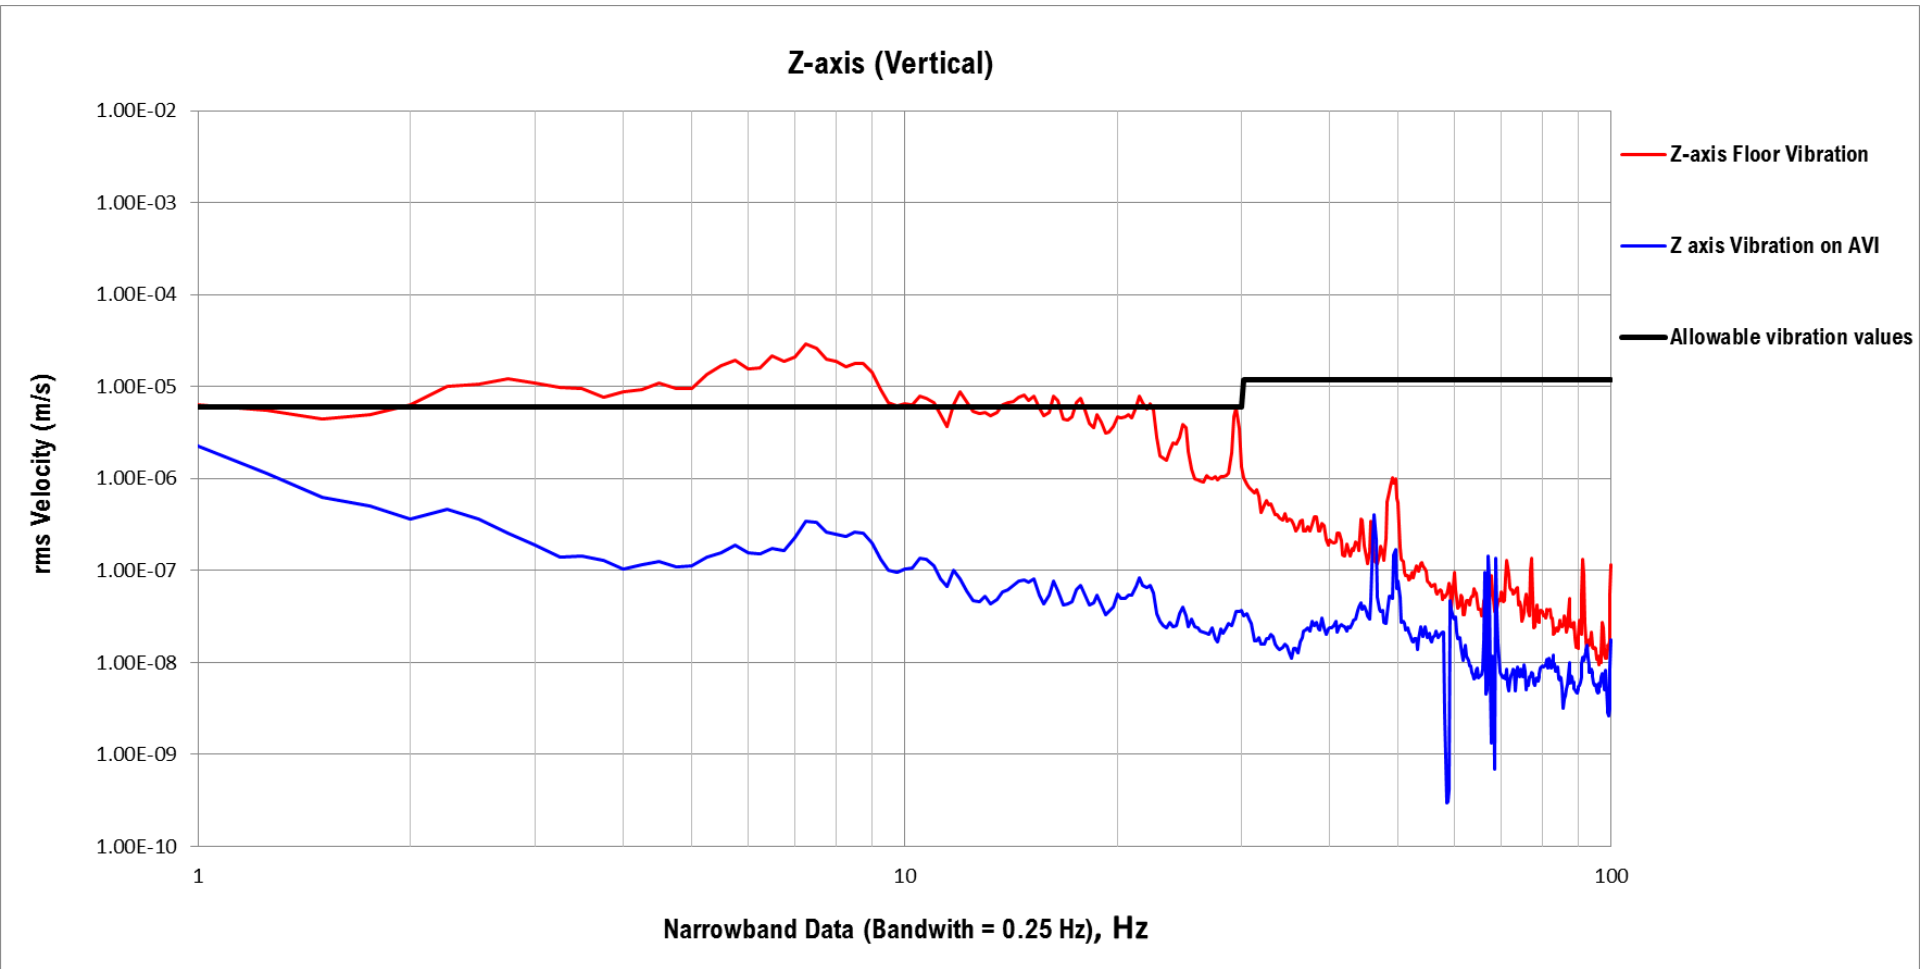
6. Results – Z axis (Vertical)

The measured vertical floor vibration exceeded the allowable floor vibration values from 1 to 22.8 Hz. The active vibration isolation system reduced the vertical floor vibration to below the allowable vibration values.

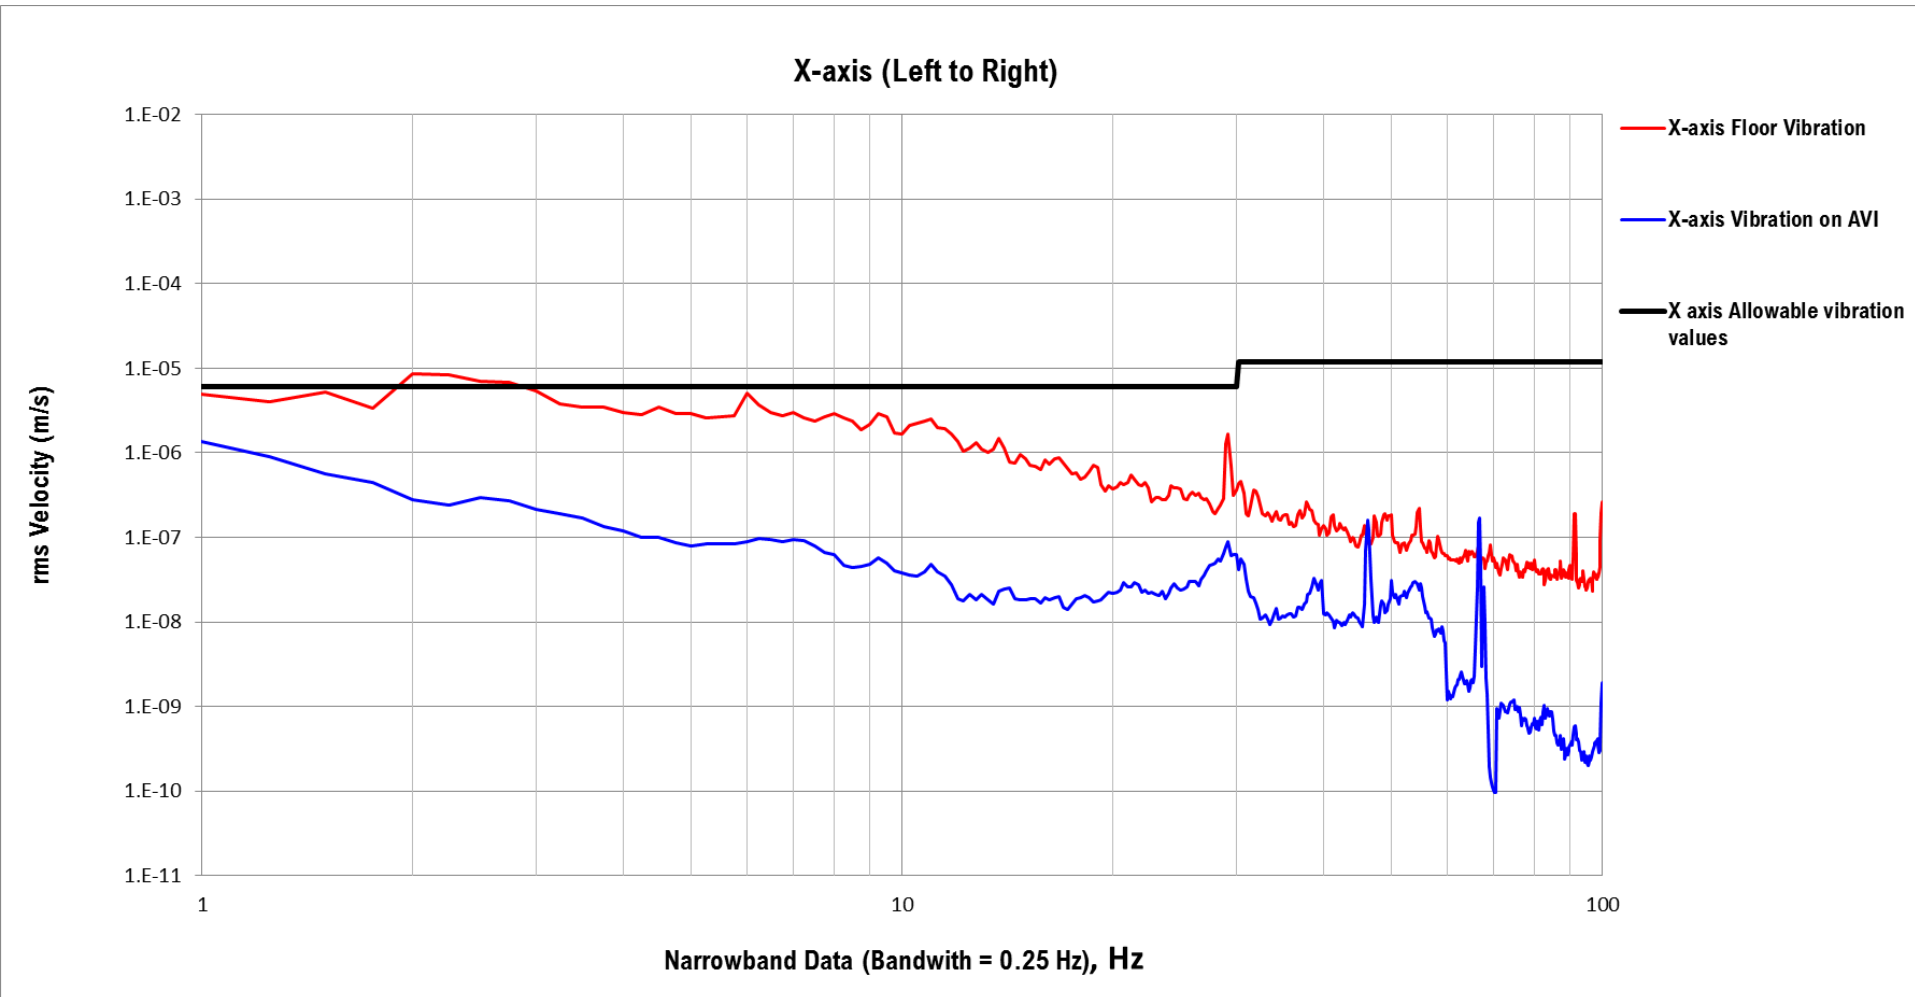
6. Results – X-axis (Left to Right)

The measured X-axis floor vibration exceeded the allowable floor vibration values from 2 to 3 Hz. The active vibration isolation system reduced the X-axis floor vibration to below the allowable vibration values.

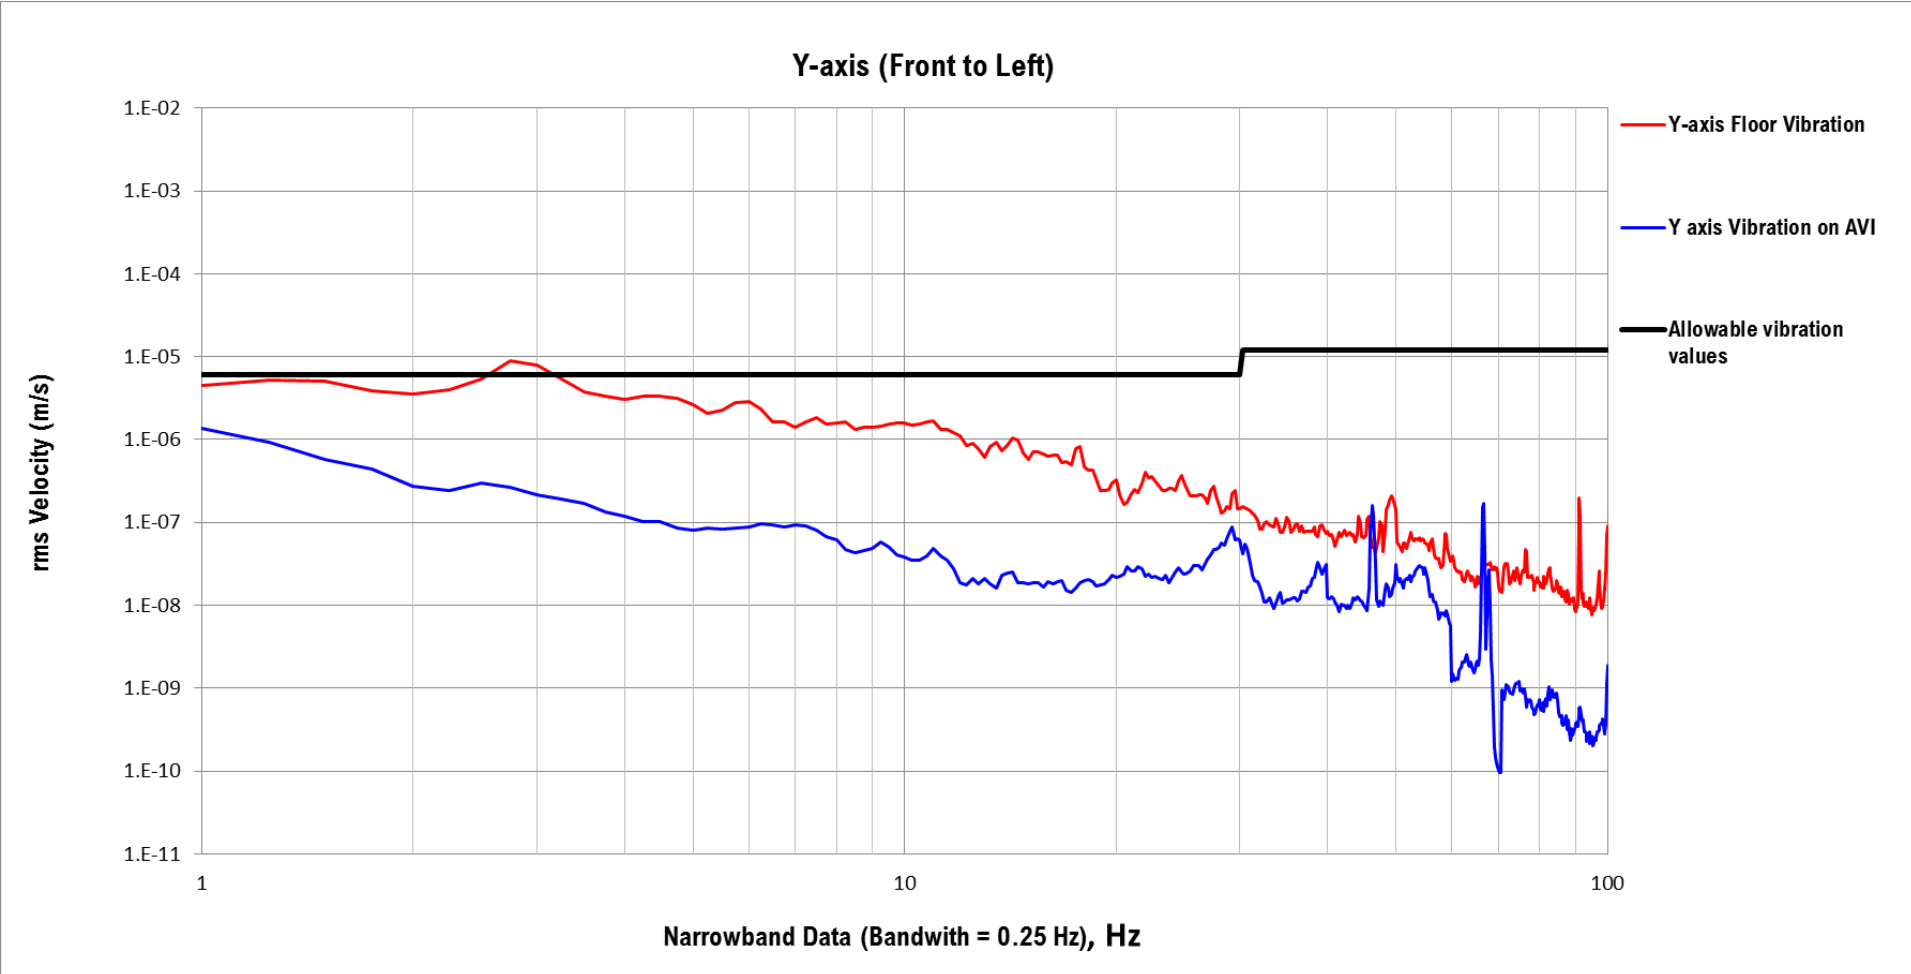
6. Results – Y-axis (Front to Back)

The measured Y-axis floor vibration exceeded the allowable floor vibration values from 2.5 to 3.25 Hz. The active vibration isolation system reduced the Y-axis floor vibration to below the allowable vibration values.
